GROTON ENGINEERING, LLC

FOUNDATION ASSESSMENT
for the
1784 Levi Wetherbee Farmhouse
484 Middle Road, Boxborough, MA 01719
July 17, 2014

CLIENT: Town of Boxborough
Town Hall, 29 Middle Rd.
Boxborough, MA 01719

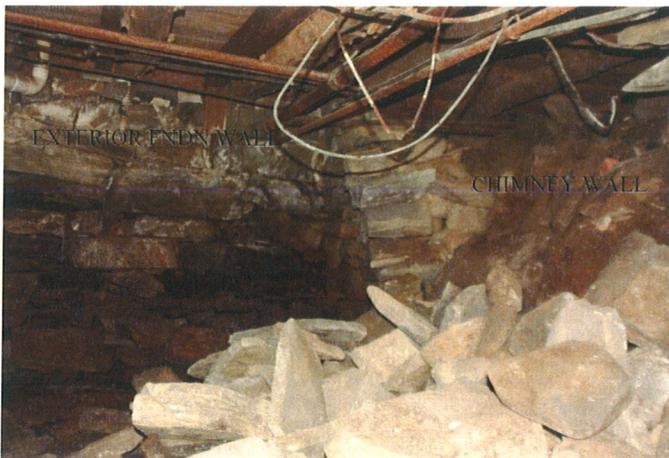
PHOTO #1 - Wall & Fallen Stone

PHOTO #1 shows a collapsed portion of the interior fieldstone wall that surrounds the central chimney's base. PHOTO #2 shows the stone laying on the sandy floor. The soil behind the fieldstone wall and under the chimney's base is a good gravel with a blend from fine sand to two and three inch stone. The fieldstone walls are all laid up dry, ie, no mortared joints. They are well built but depend on heat radiating from the basement to prevent frost buildup that can damage fieldstone walls.

When frost enters soil it causes any moisture therein to freeze and expand. That expansion pushes against the fieldstone that only has friction to resist sliding. When frost leaves in the warmer months, the water-soaked sand slips into the cavities created during the freezing/sliding action. Repetition over a period of years eventually forces stones to slide far enough that they fall out of a wall and cause others to go with them. That is what I believe has happened here. There is still soil behind the remaining wall and under the chimney but how compact and stable it is now, is not known.

So we have a house that needs foundation, chimney and floor framing restoration. While at the site and discussing restoration or just shoring options for the chimney, I suggested the use of needle beam shoring under just the chimney and extending out beyond those related retaining walls. When discussing this same issue with several companies that install residential shoring they said it is easier and wiser to shore up the entire house including the chimney because the house is relatively small and purely rectangular. Just slightly lifting a chimney while the house is not moved is difficult. Shoring the whole house allows for easier lifting. Once that is done and depending on funds, then the whole house becomes ready for renovation. The house can be lowered back onto the new foundations afterwards. Some wood sill work may have to be done prior to installing shoring and some other work may have to wait until the house is lowered back into place.

Replace existing fieldstone foundations with 12" concrete ones that have 4" exterior shelves to carry a veneer of fieldstone. The 8" portion, exposed to the interior of the basement, can rise up to the first floor framing and be attached thereto. The wood floor joists, sills and other damaged framing can be replaced with like kind at greater expense or replaced with today's conventional lumber that meets code.

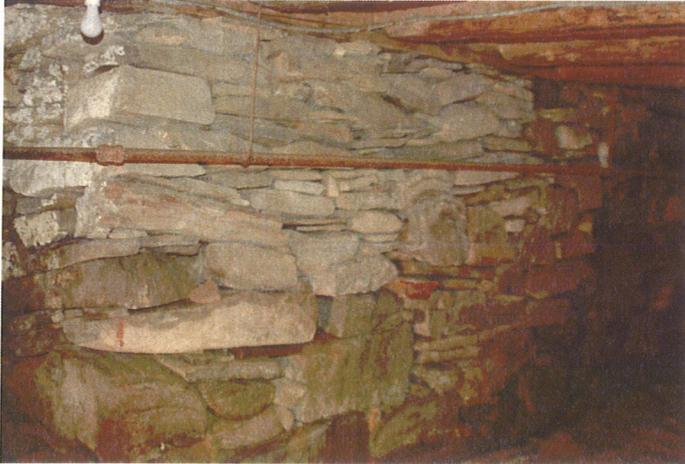
PHOTO #3 - Other Wall Supporting Chimney

The fieldstone retaining wall on the opposite side of the chimney is still in fairly good condition as can be seen in PHOTO #3. Also visible in this photo are the first floor joists of logs rather than sawn or hand hewn lumber. The beams to which the joists are connected, are hand hewn lumber. The wood framing is where it is supposed to be so this retaining wall is still doing its job. On the collapsed fieldstone wall the corresponding wood framing above has lost support.
